# Debris/Ice/TPS Assessment and Integrated Photographic Analysis for Shuttle Mission STS-59

DEBRIS/ICE/TPS ASSESSMENT  
AND  
INTEGRATED PHOTOGRAPHIC ANALYSIS  
OF  
SHUTTLE MISSION STS-59

April 9, 1994

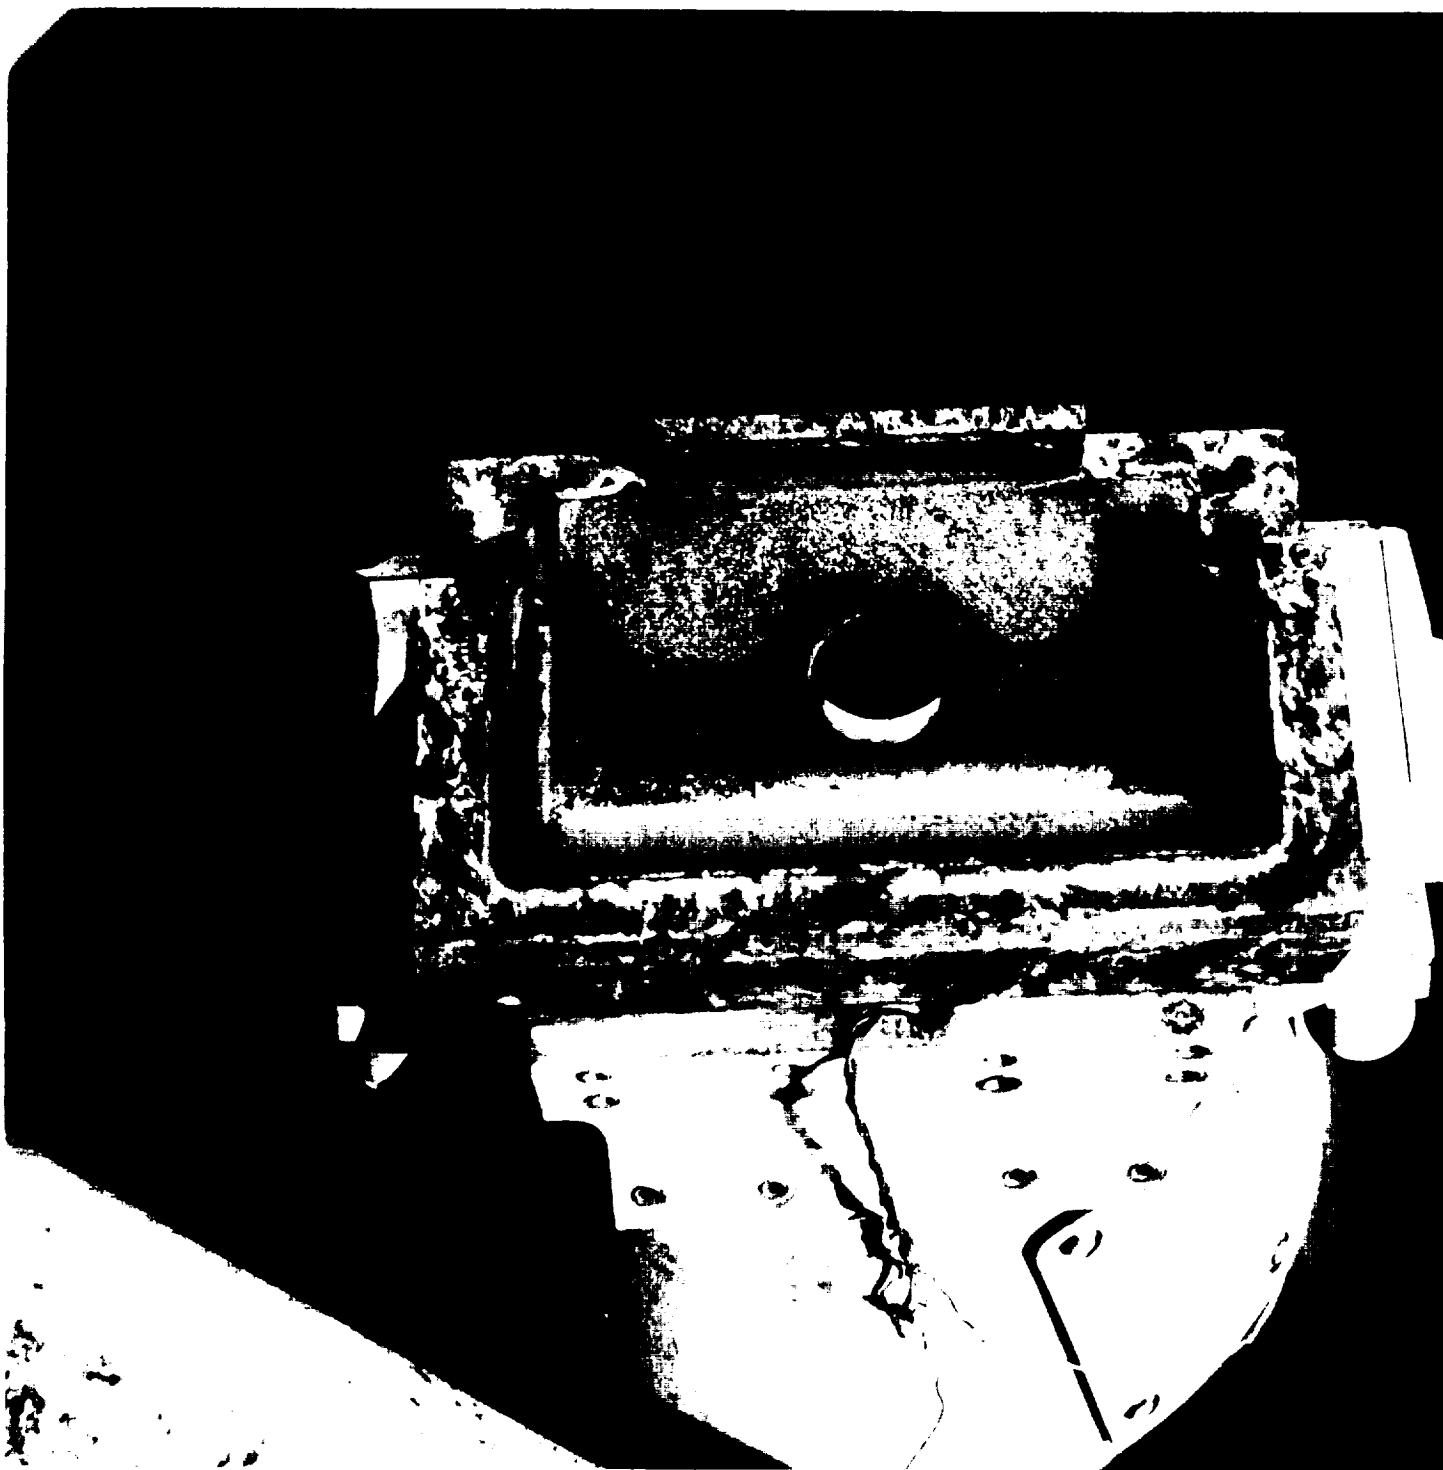
South SRB holddown post erosion was typical. All south HDP shoe EPON shim material was intact.

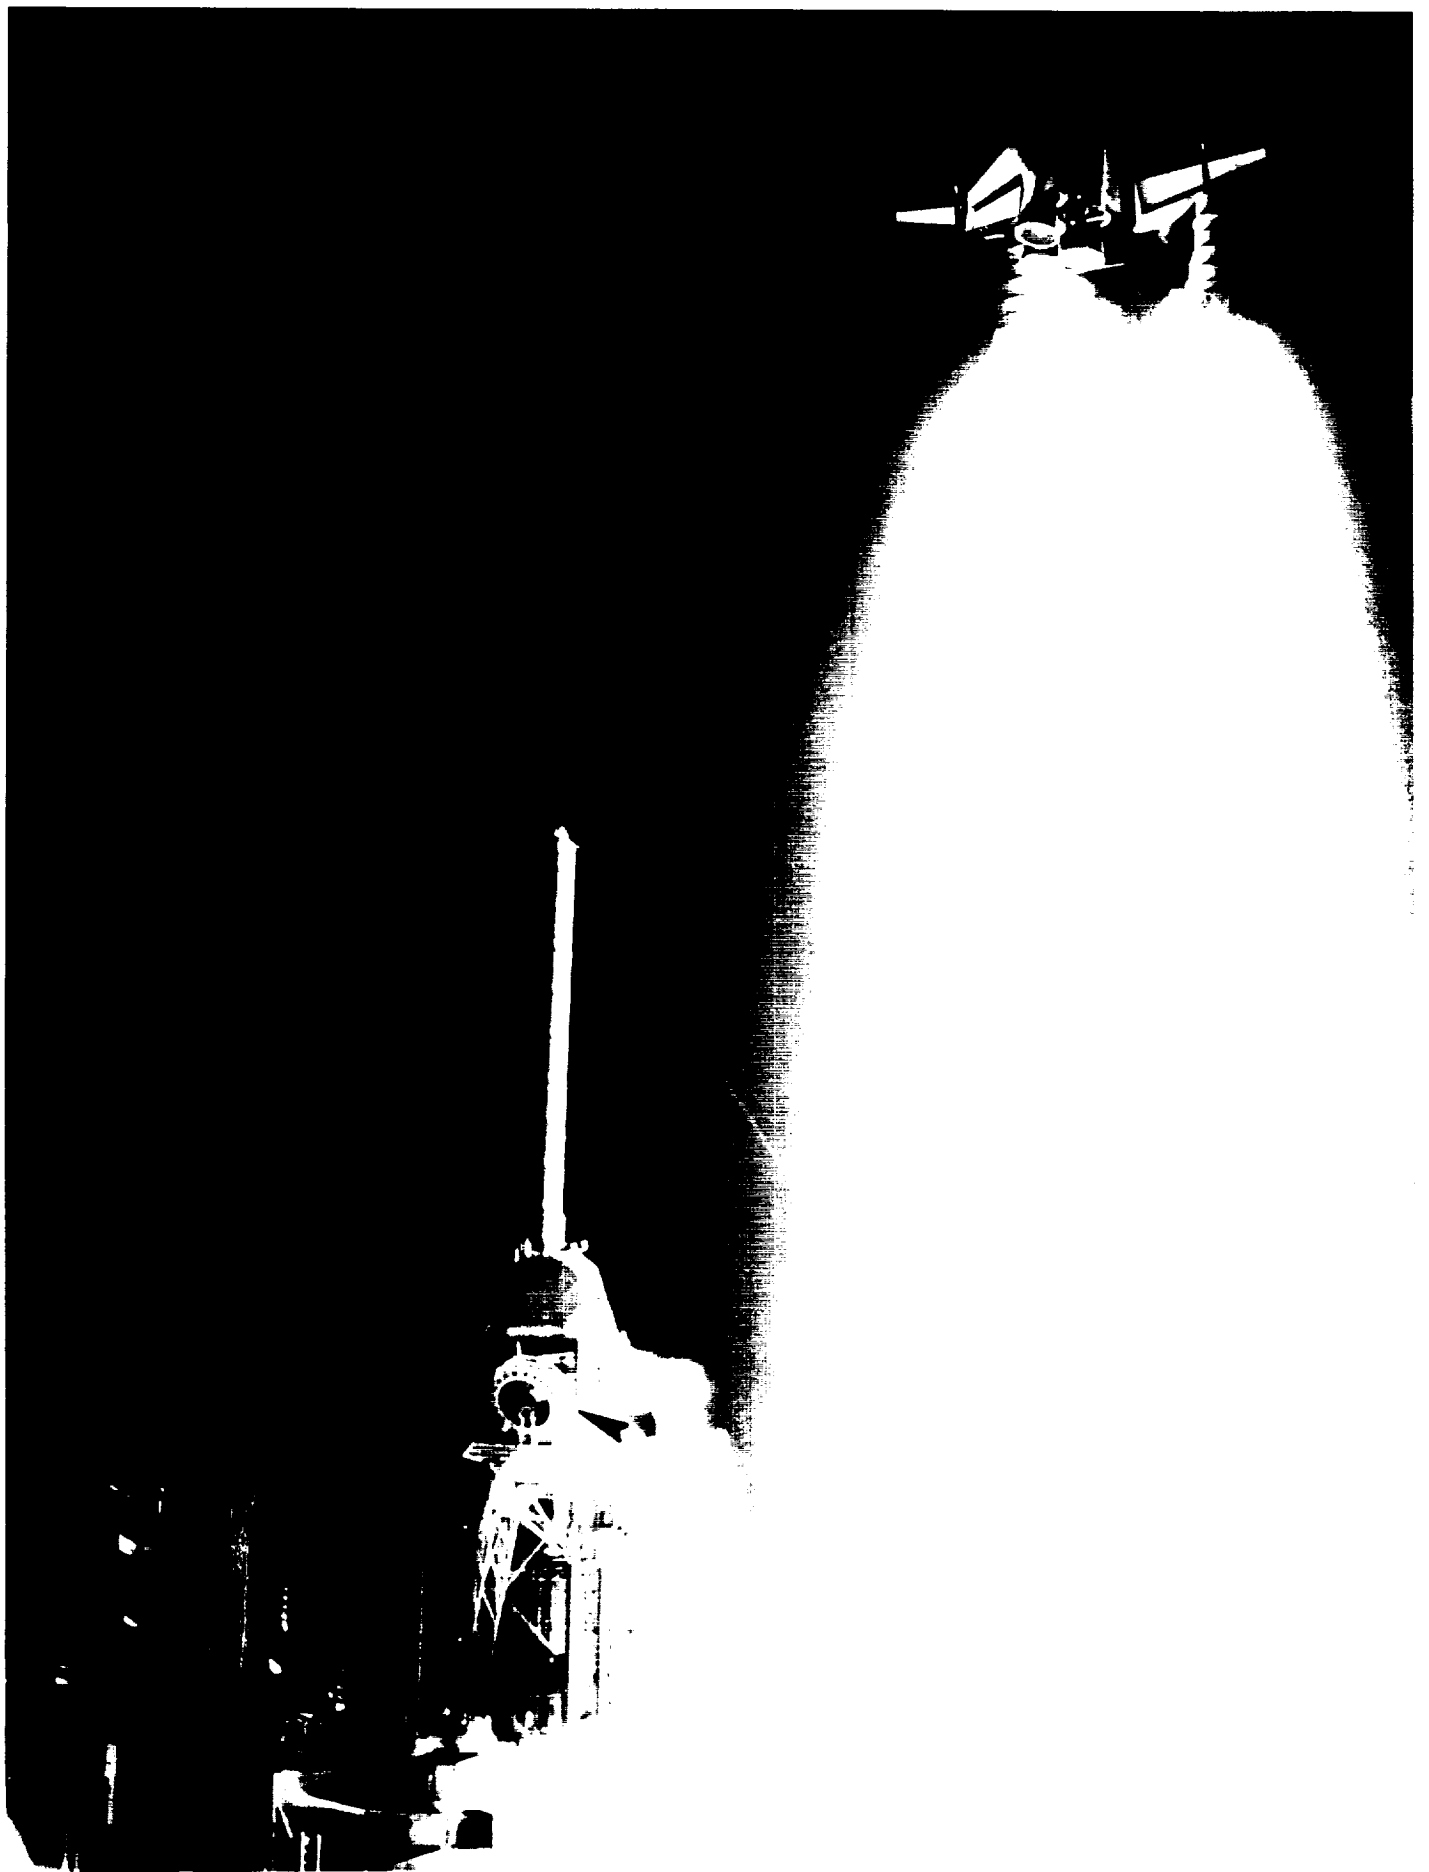
Post launch inspections revealed significant damage to the GOX Vent Arm at the axial adjustment attach point. Several welds were broken and the piston housing had collapsed. This damaged caused the hood to be skewed or twisted 1-2 inches from the centerline. Vibration/acoustic shock waves from the SRB plume and 16 knot winds from the east (105 degrees) at the time of launch are believed to be related to the failure. Some of the damage was attributed to improper welds (IFA STS-59-K-01).

A strong easterly wind and vibration/acoustics from the SRB exhaust plume caused damage to the ET Gaseous Oxygen Vent Hood and a box of emergency breathing units in the White Room.

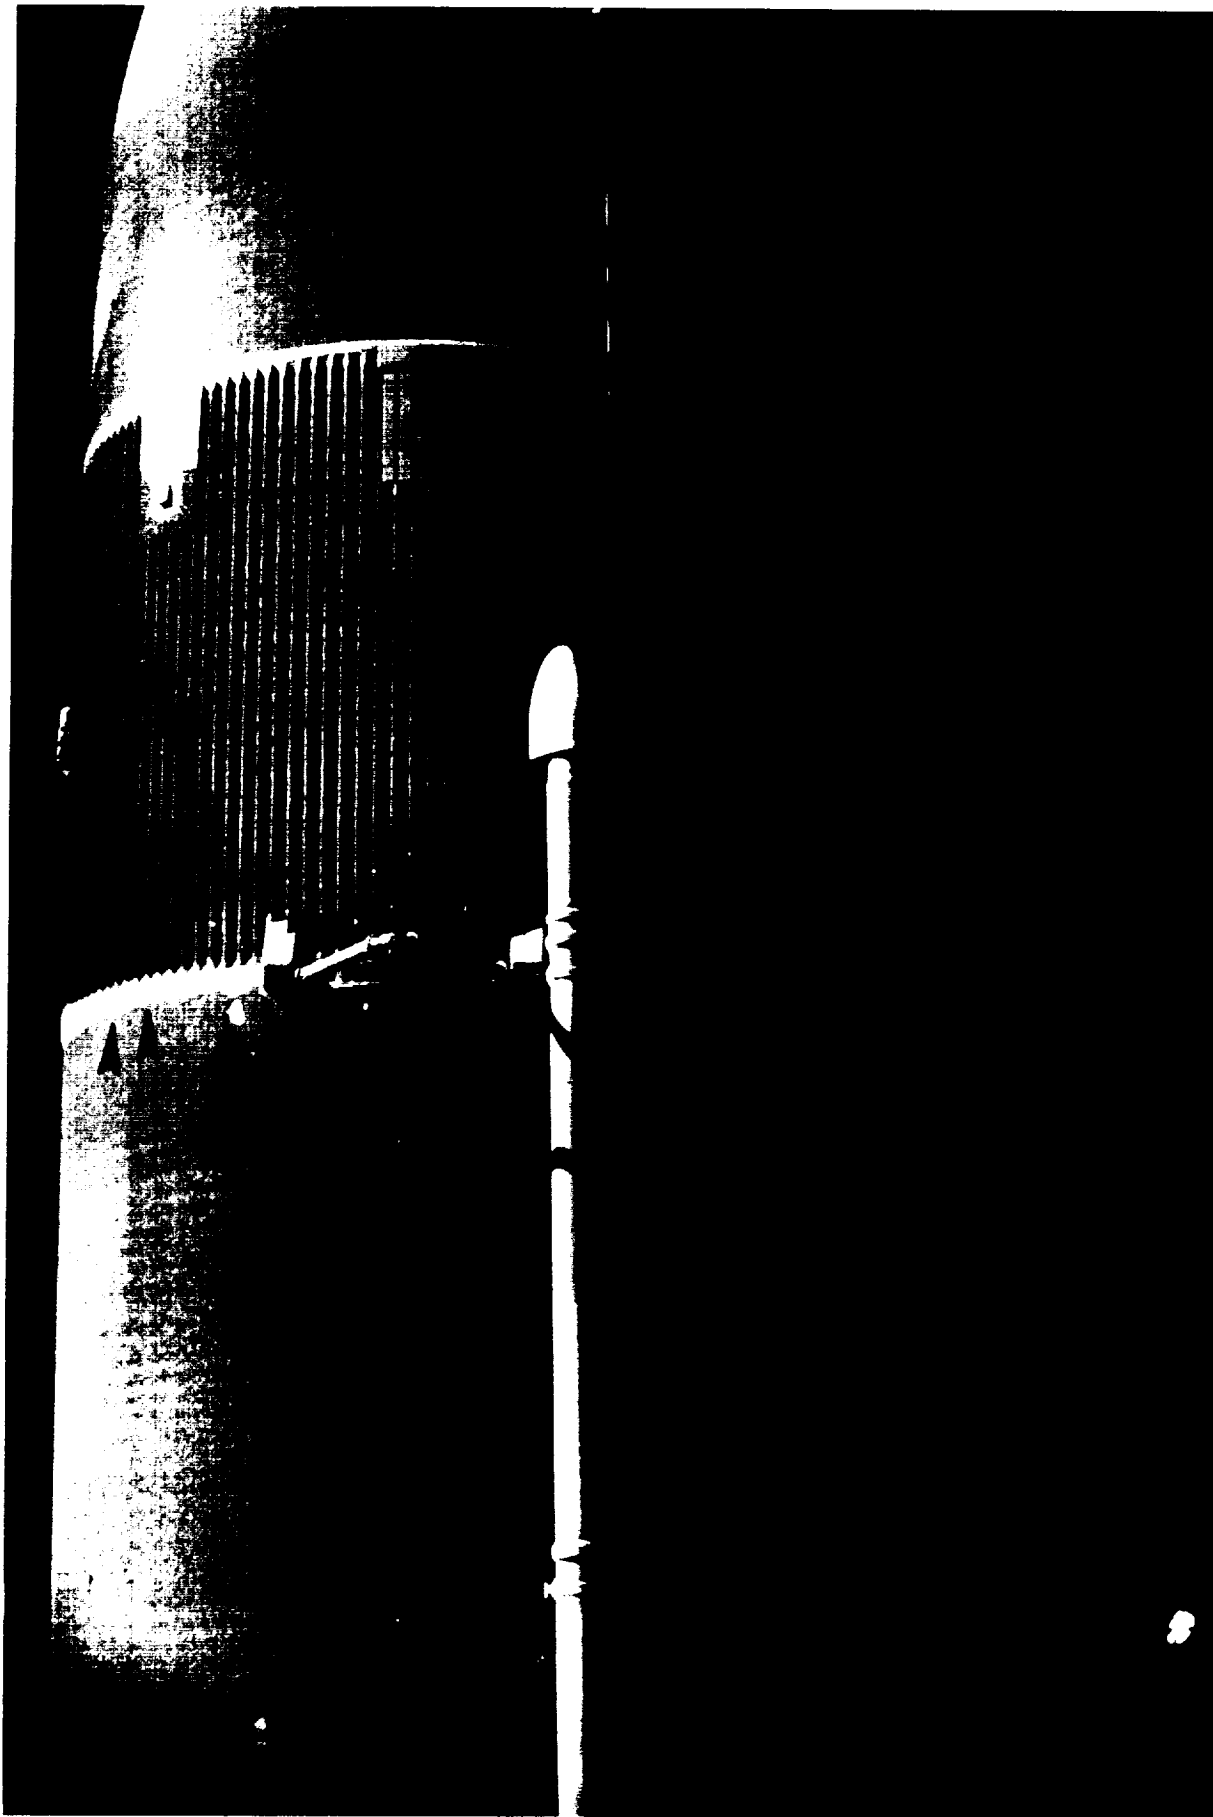
The bipod jack pad closeouts were intact. An 8-inch diameter divot with exposed primer occurred in the LH2 tank acreage near the left bipod. Six divots were visible in the intertank-to-LH2 tank flange closeout. Note unusual shaped ice in lower corner.

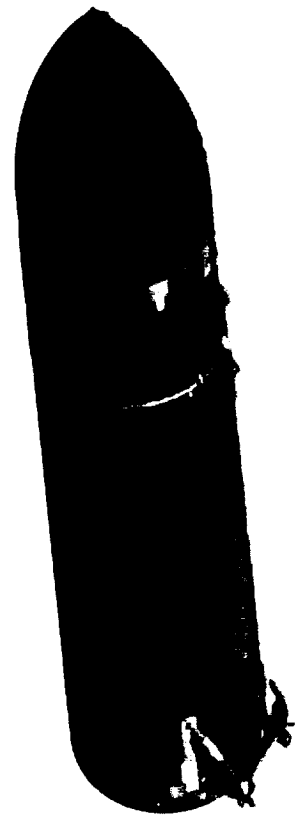
No anomalies were observed on the nose cone or acreage areas of the LO2 tank, intertank, and LH2 tank (-Y and -Z sides). Nine divots occurred in the intertank-to-LH2 tank flange closeout between the left bipod and the -Z RSS antenna.

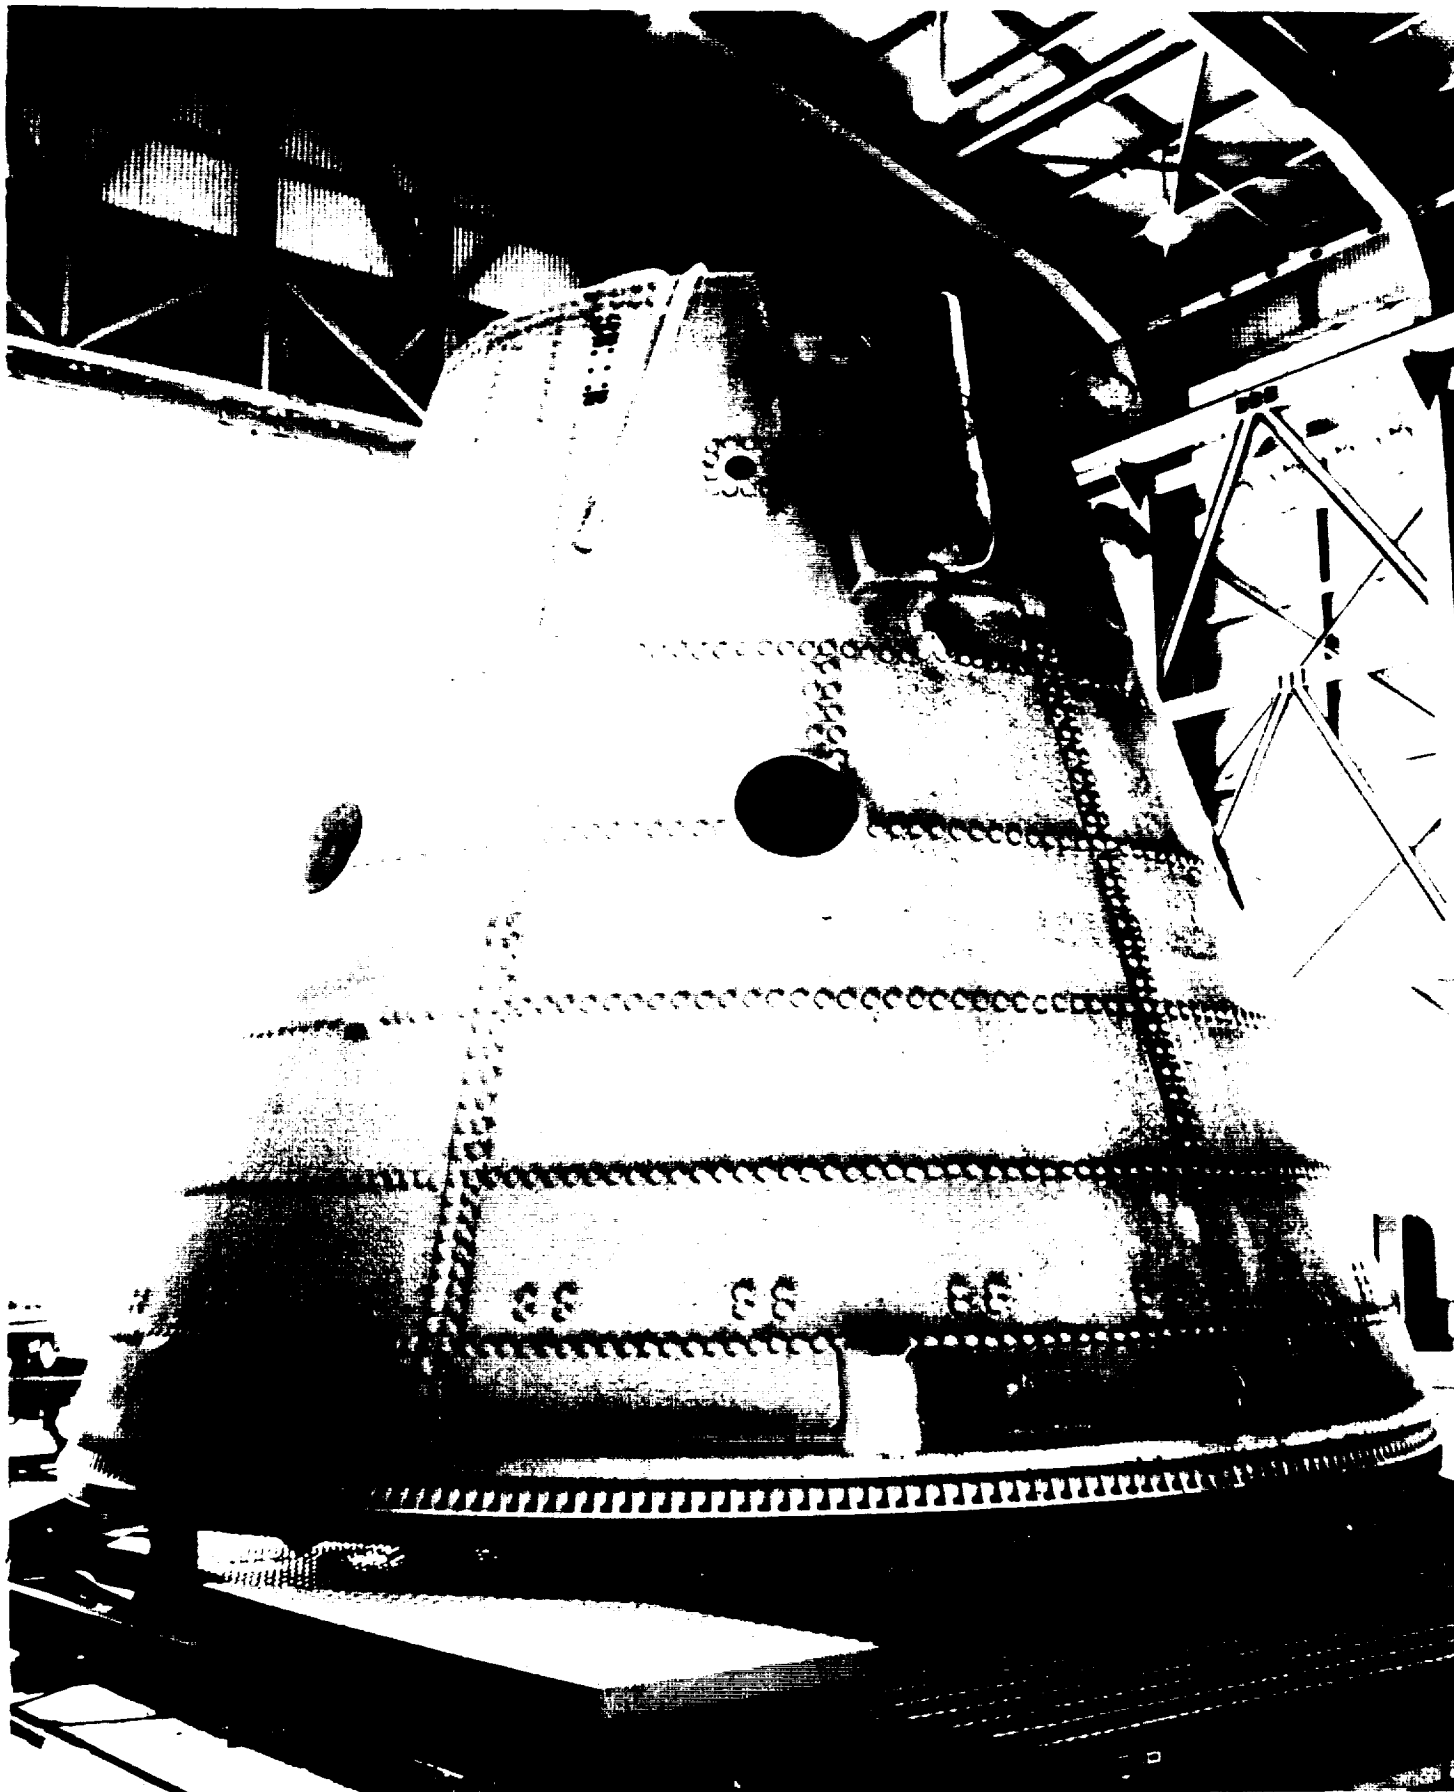
The RH frustum was missing no TPS but had 23 MSA-2 debonds over fasteners. Blistering of the Hypalon paint was minimal. The BSM aero heat shield covers had locked in the fully opened position

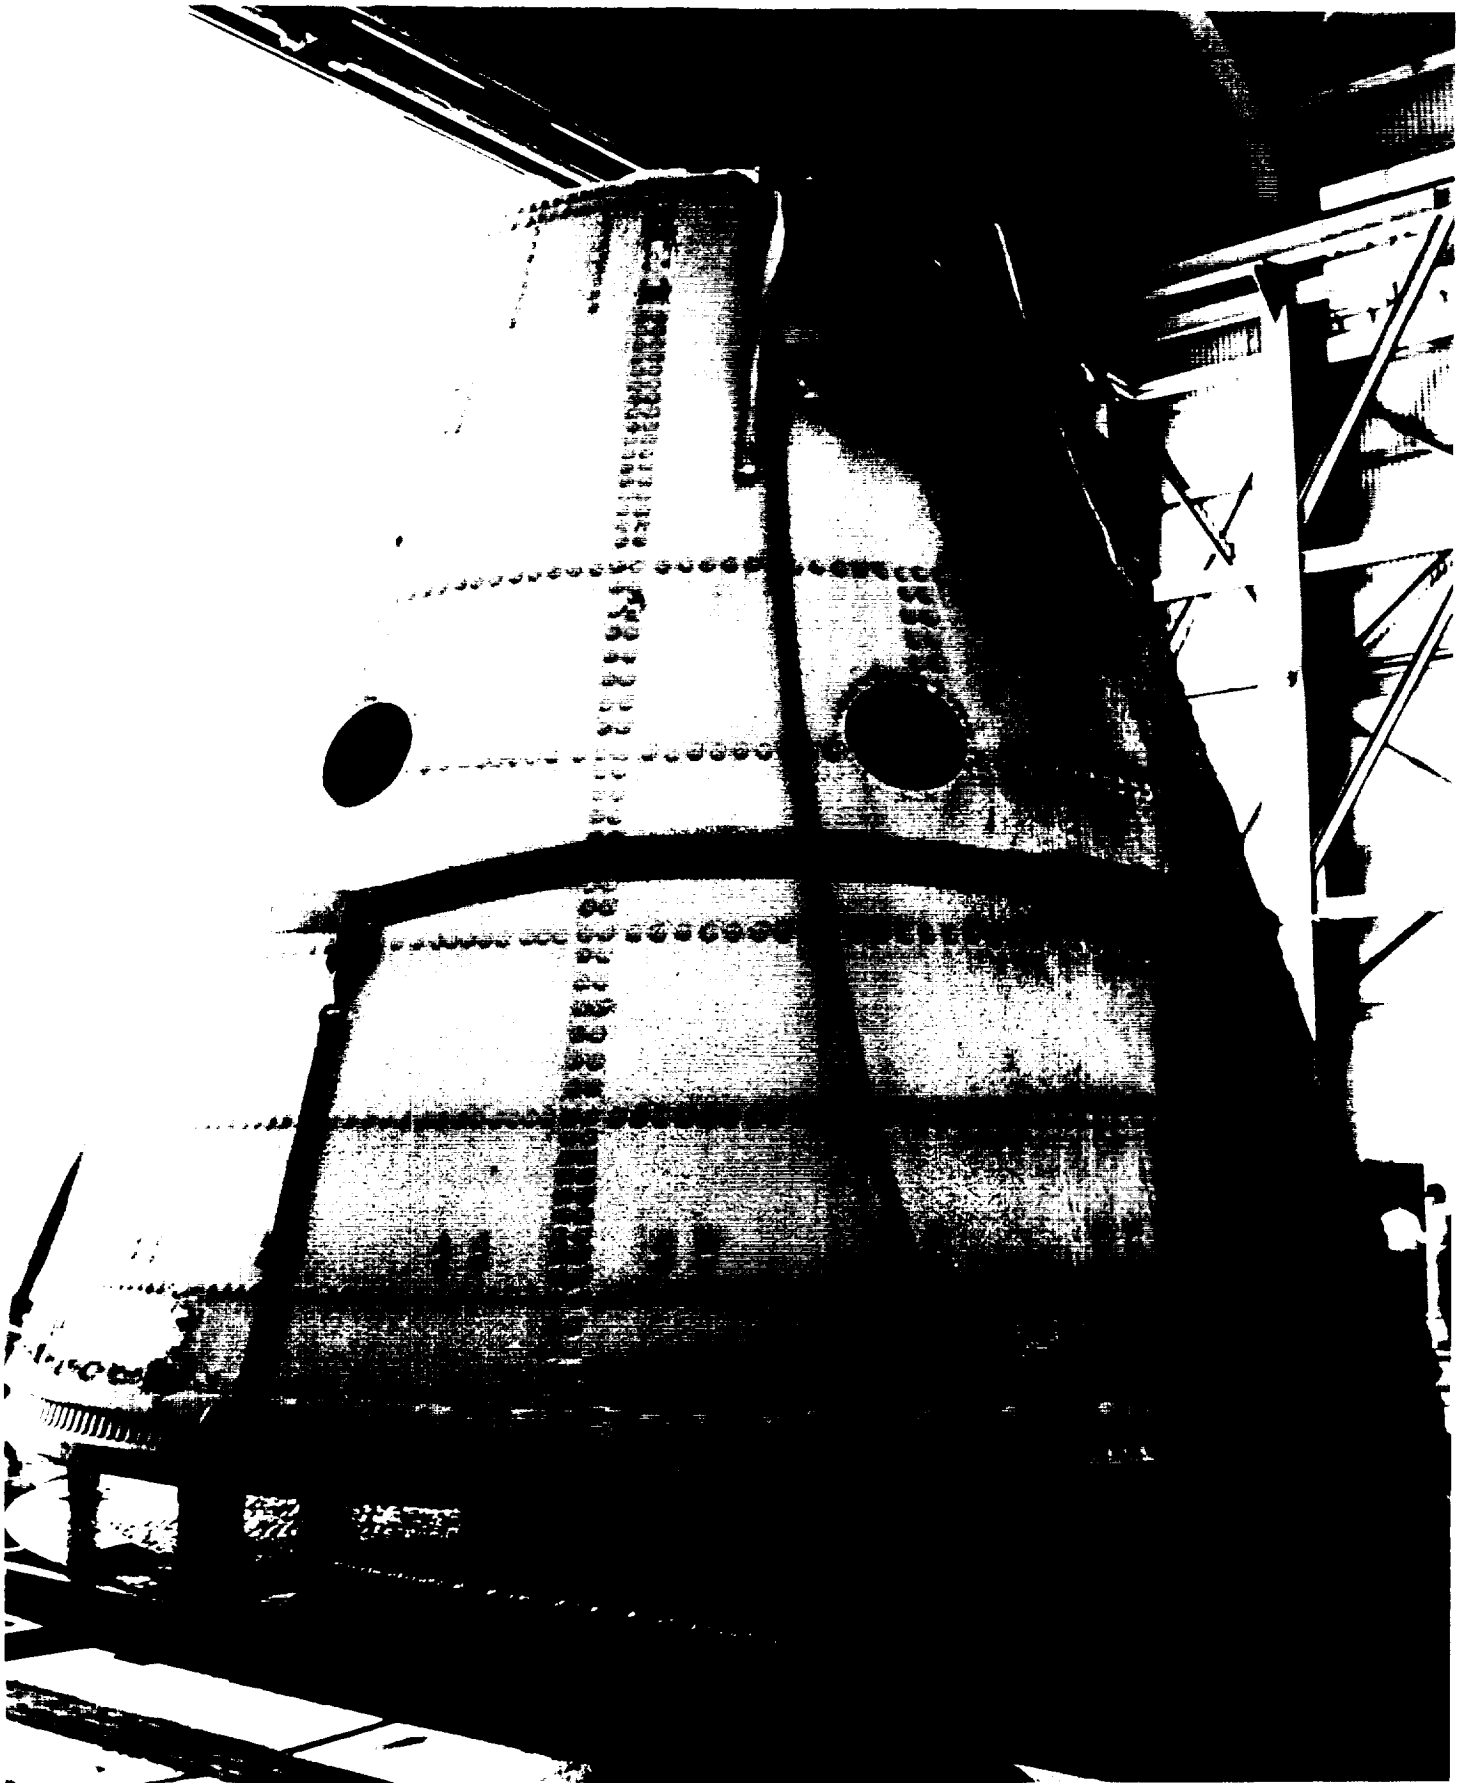
The LH frustum had a total of 17 MSA-2 debonds over fasteners and 6 acreage debonds. Significant amounts of BTA had been applied as a closeout material on this frustum.

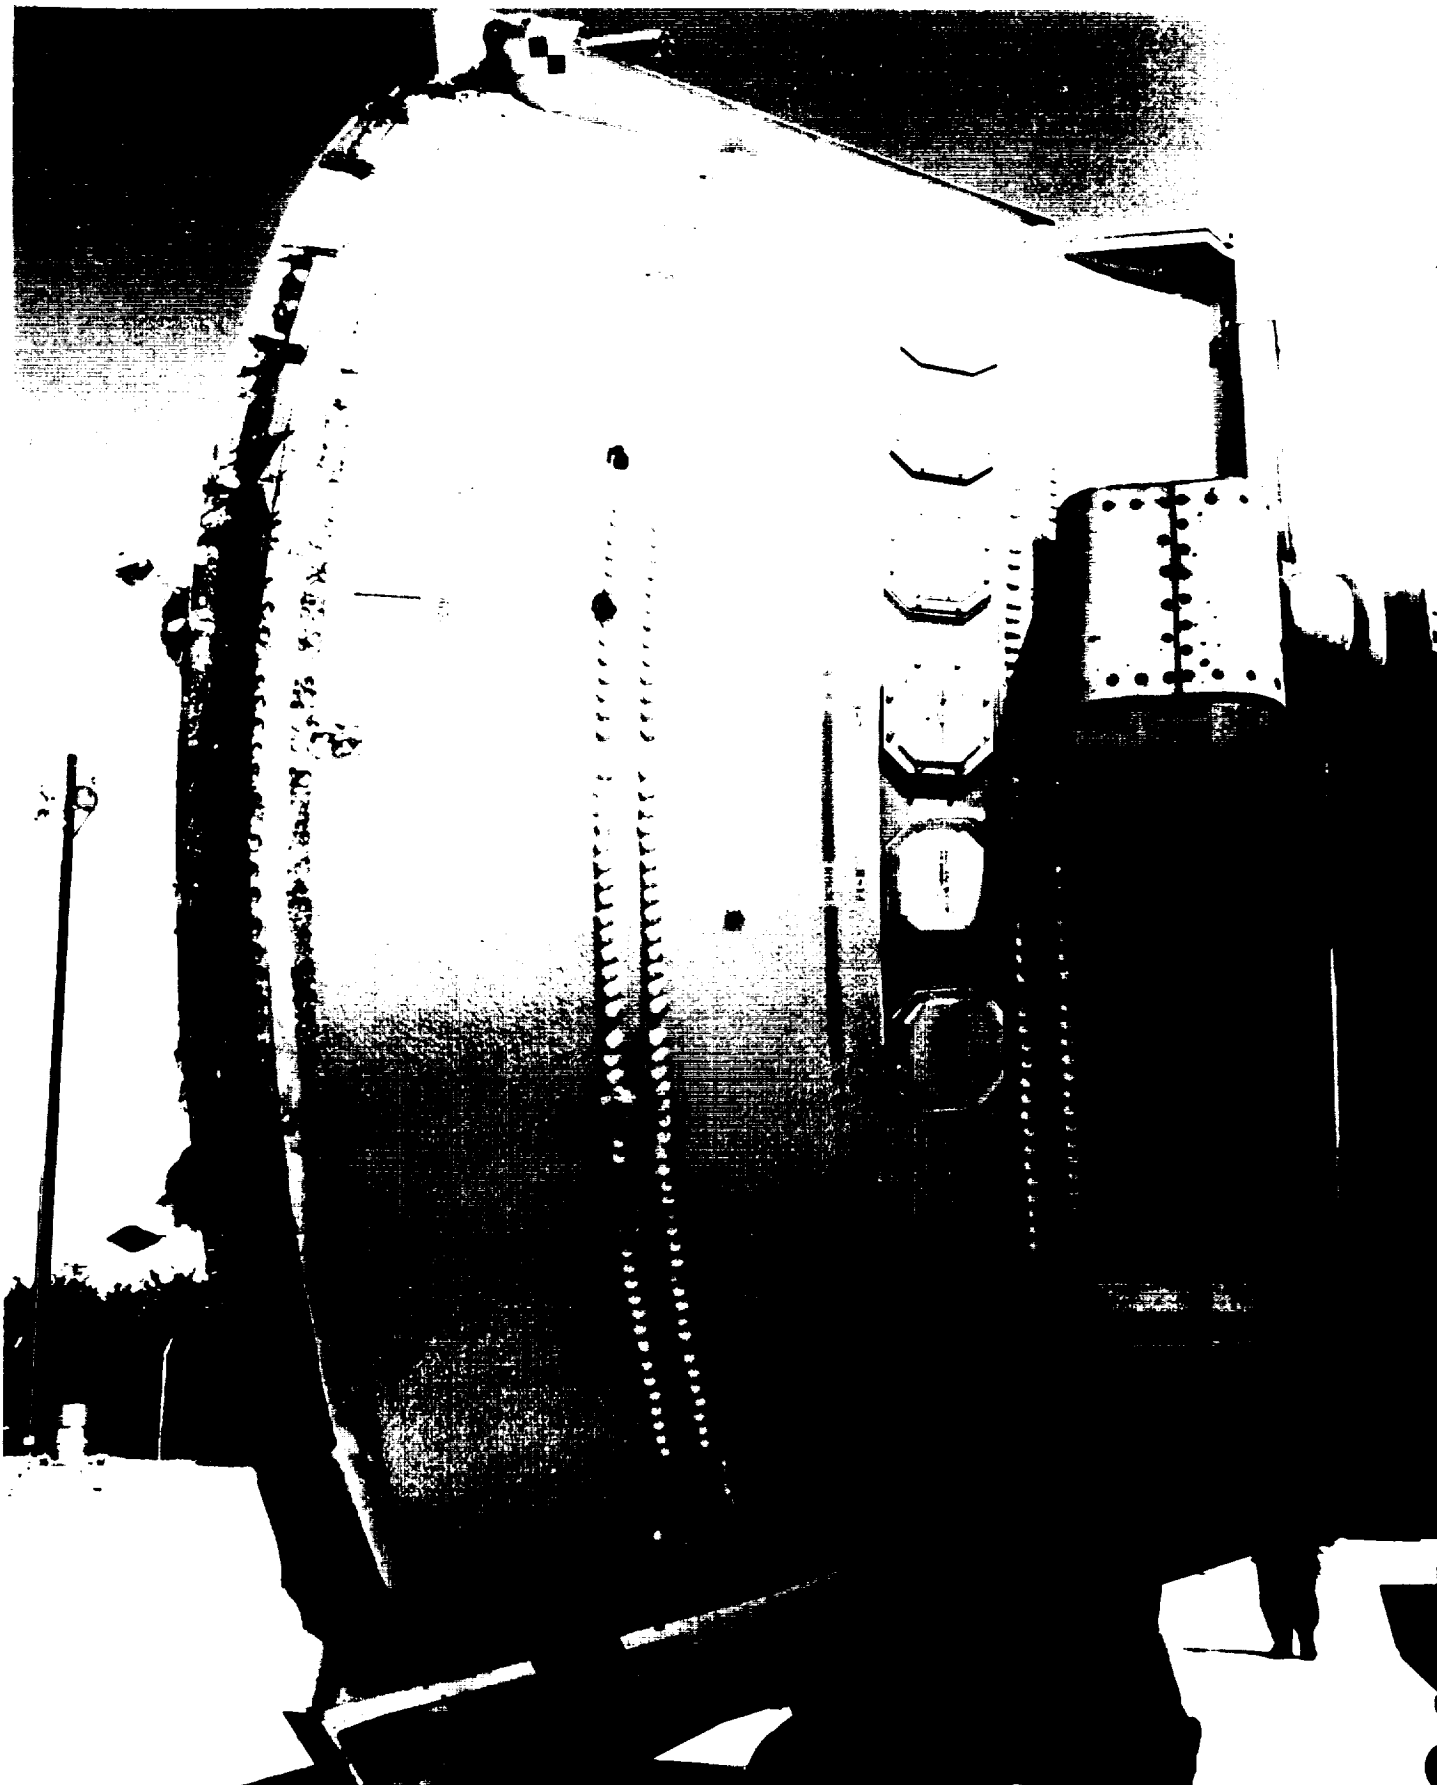
Two by two inch pieces of MSA-2 were missing from fasteners near the hydrazine service ports. Hypalon paint was blistered/missing from BTA closeout areas.

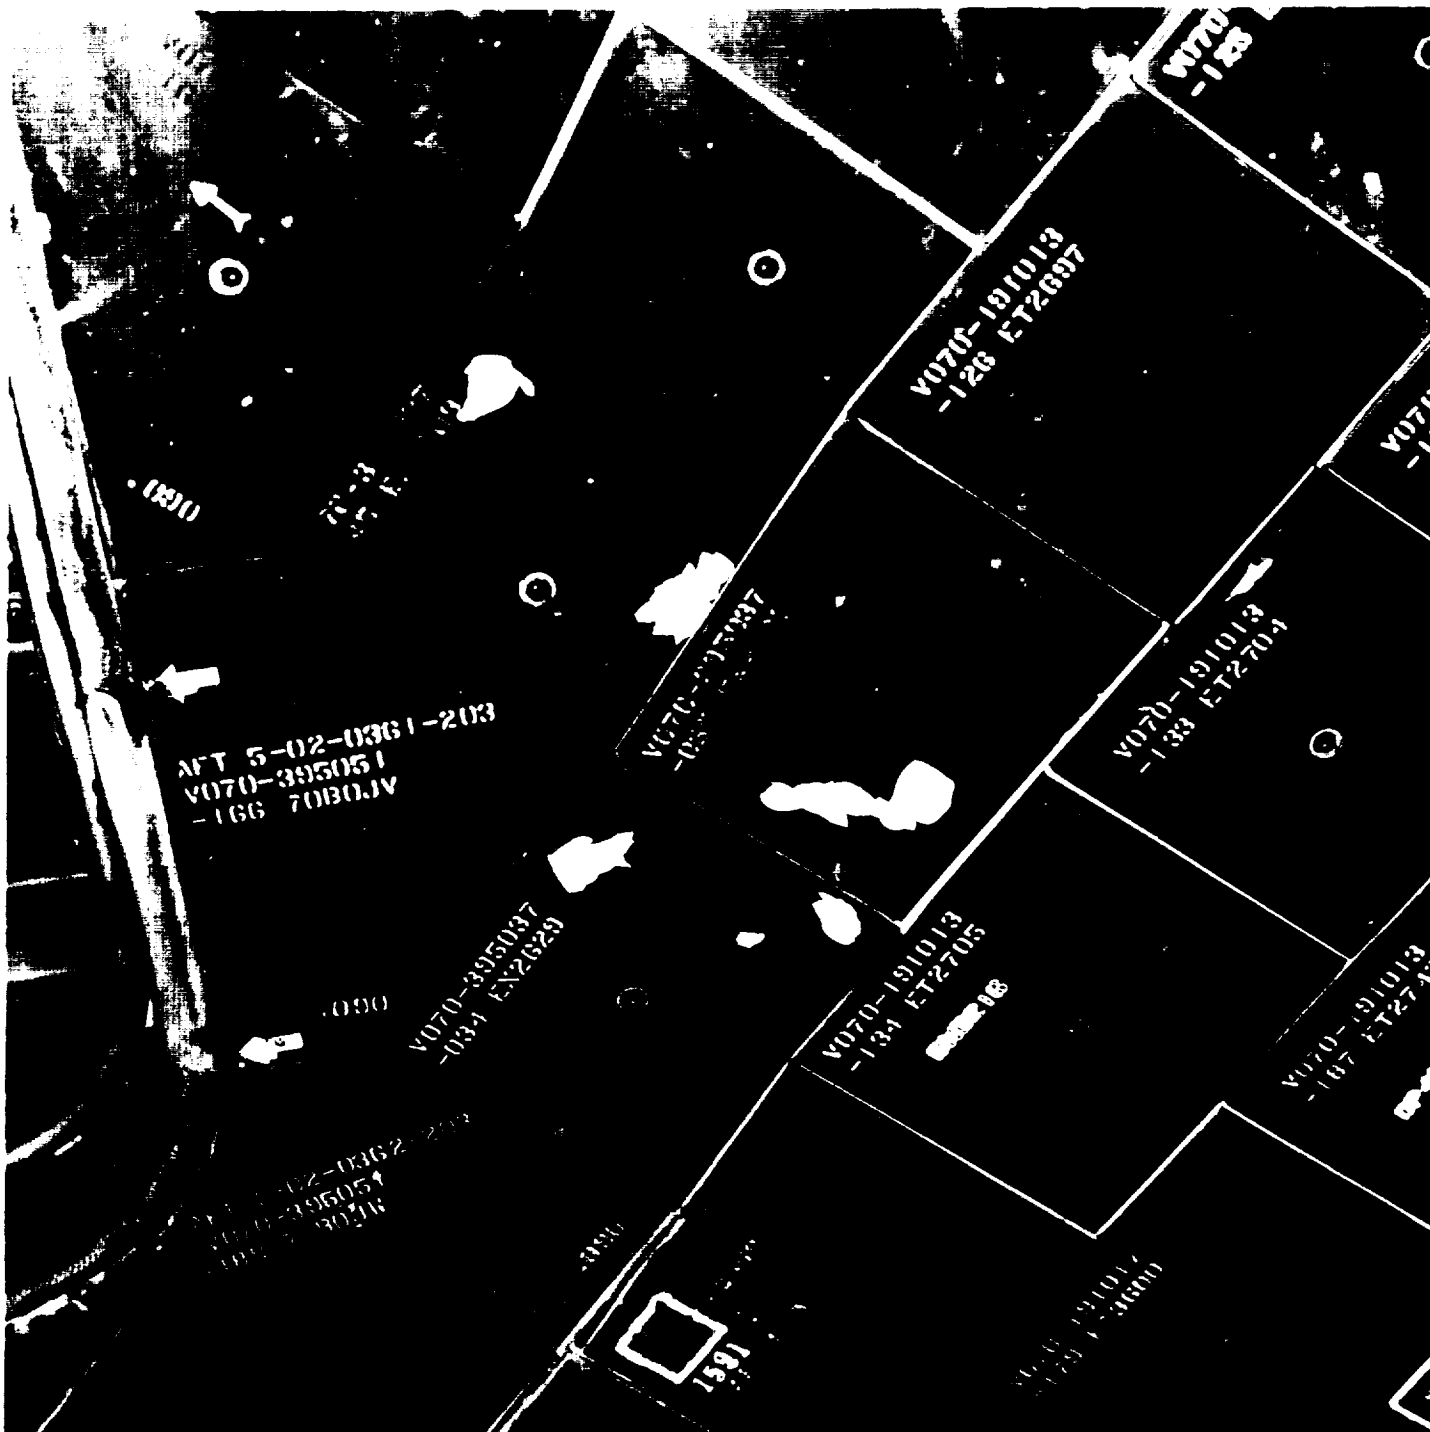
A total of 16 hits, in two clusters of 8 hits, occurred near the LH2 ET/ORB umbilical. Hits around the ET/ORB umbilicals are believed to be impacts from umbilical ice.

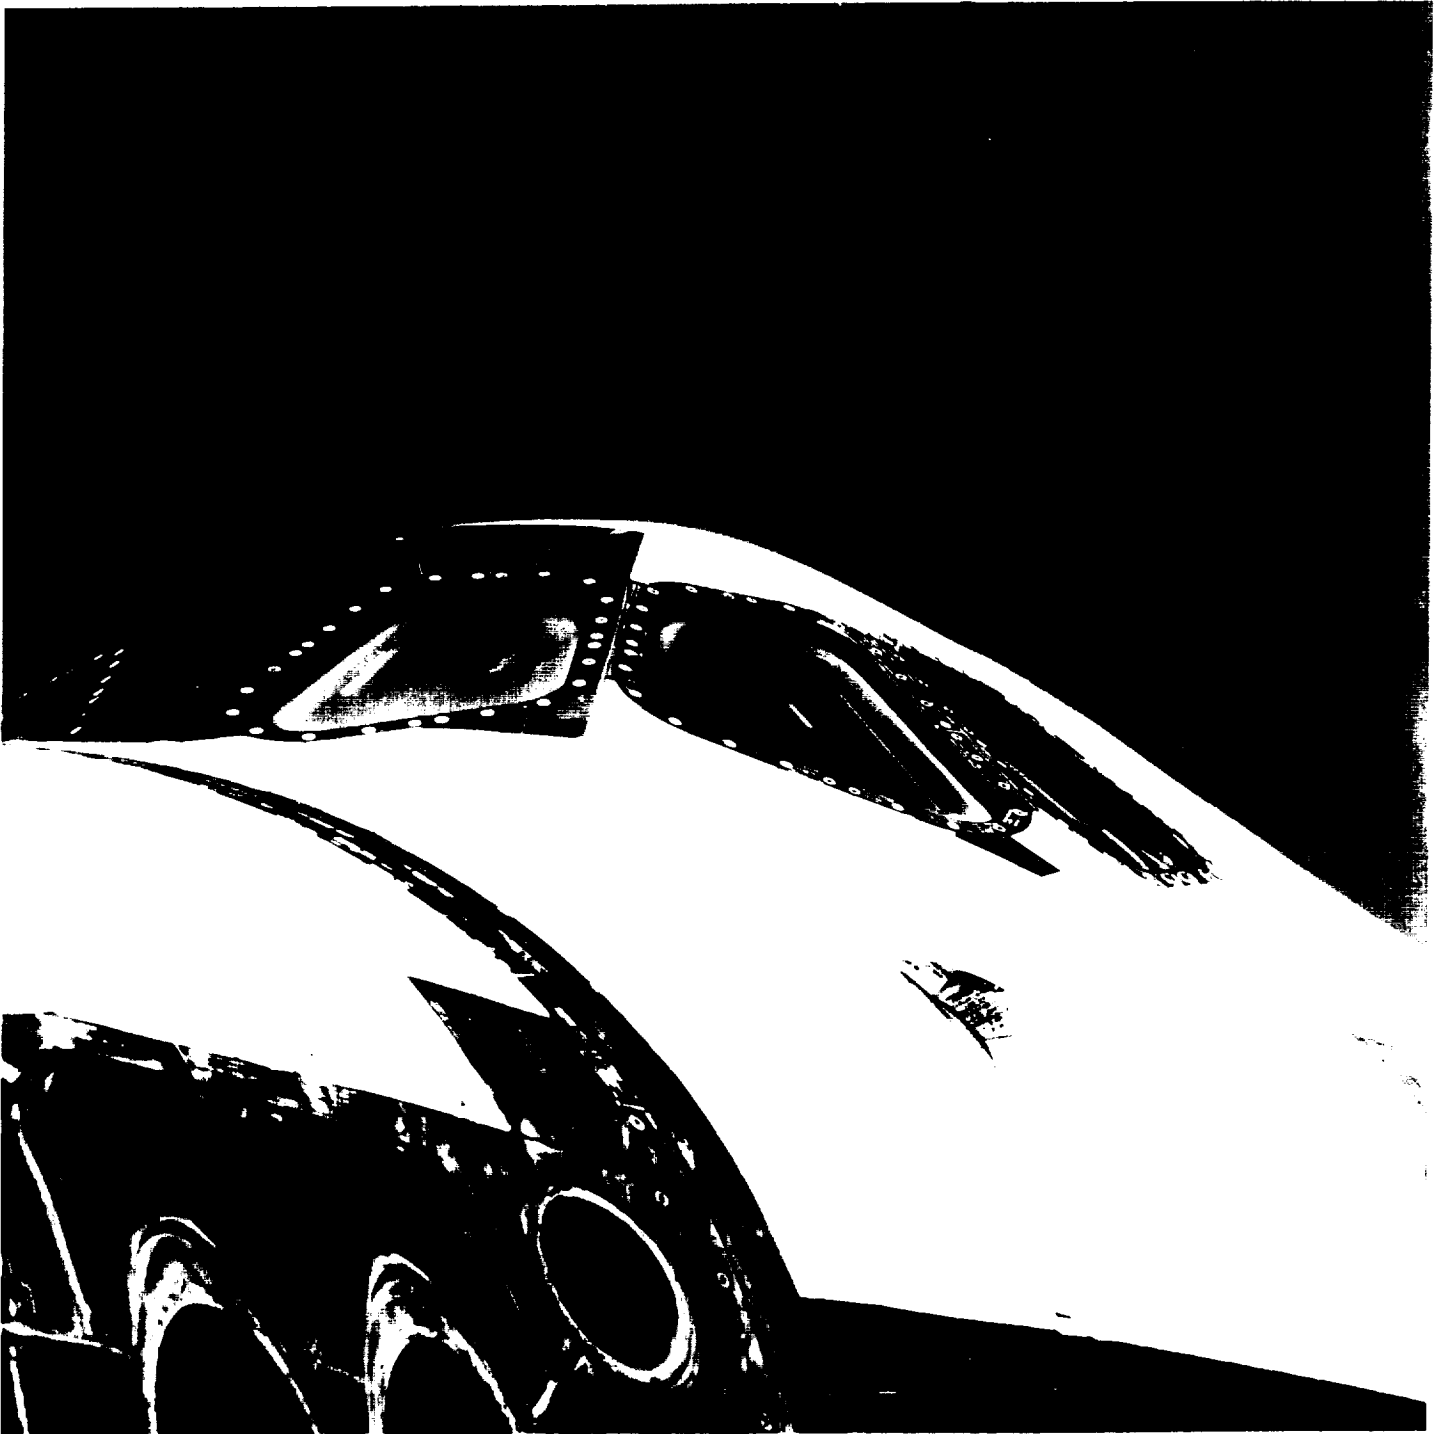
Forward-facing Orbiter windows #3 and #4 exhibited typical hazing. A very light haze was present on the other windows. Twelve hits with 8 larger than 1-inch in size were noted on the perimeter tiles around windows #3 and #5.

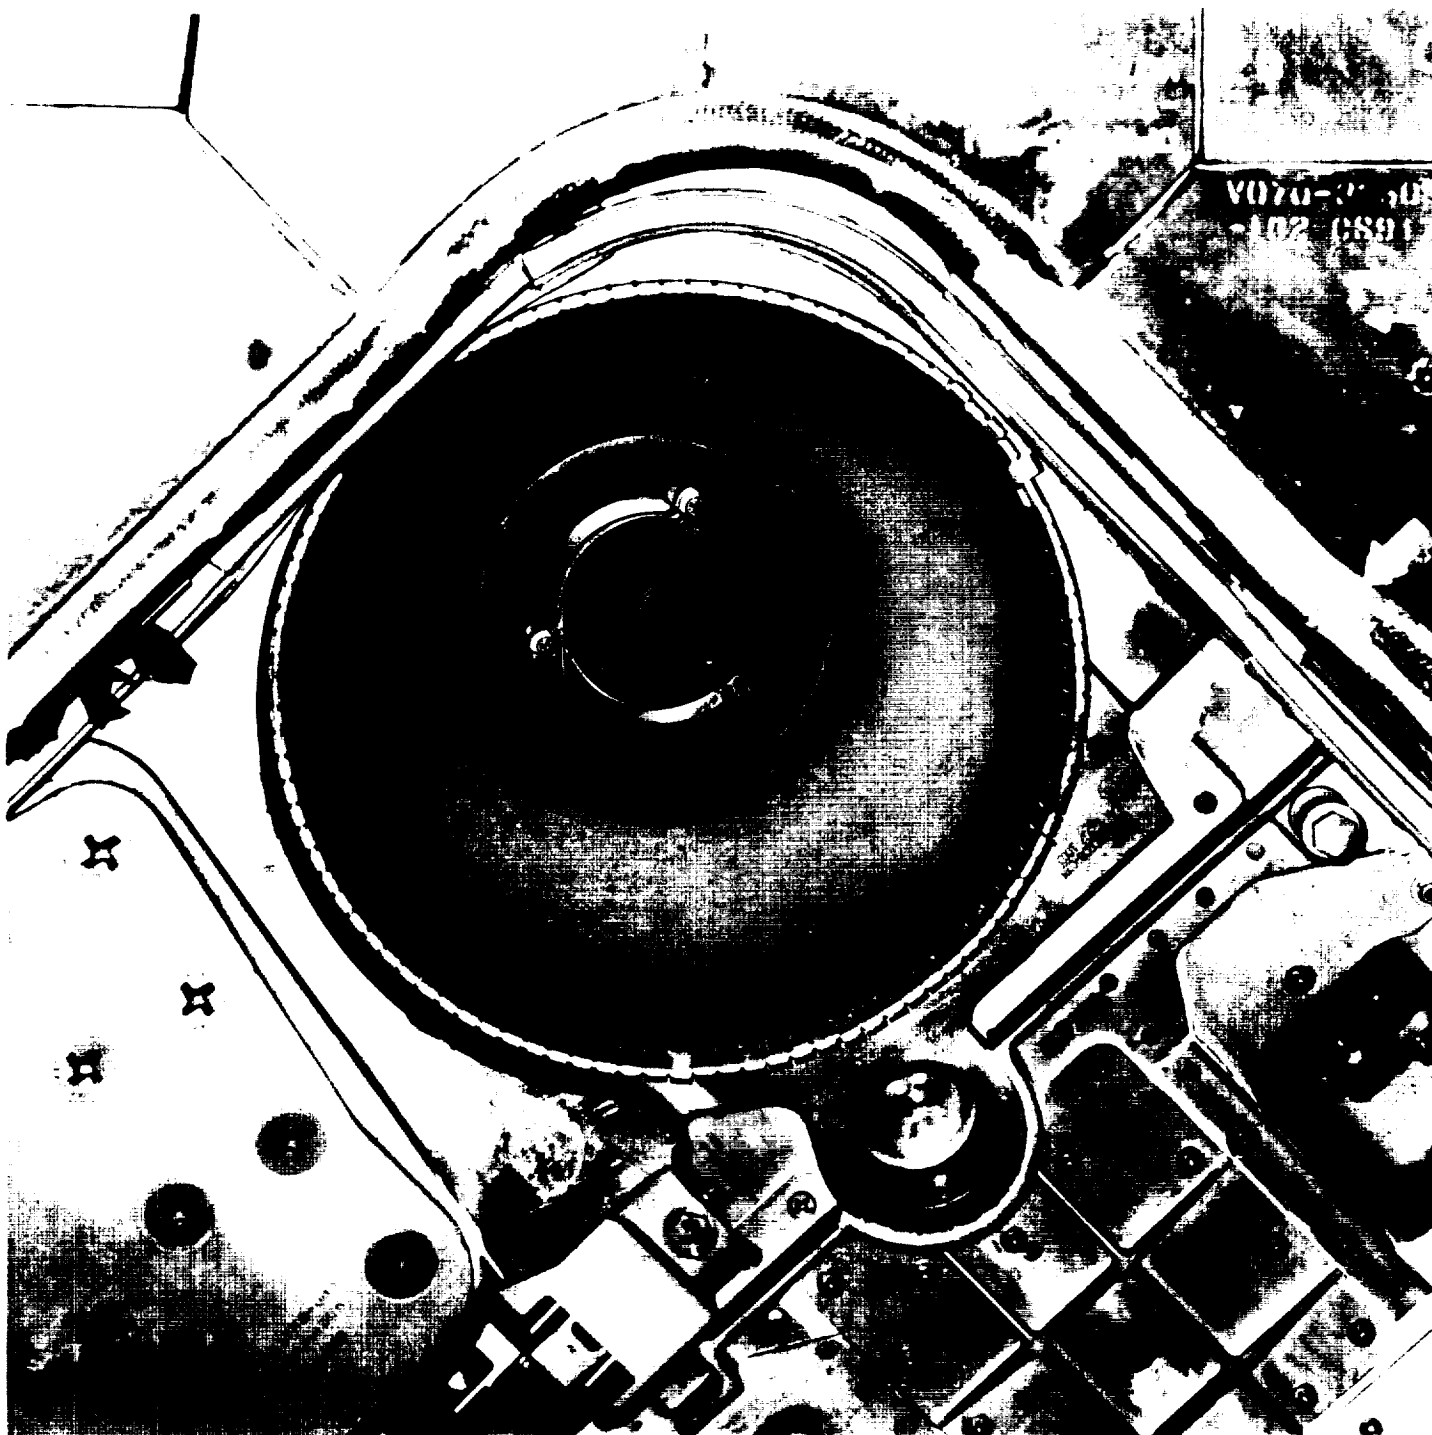
ET/ORB separation devices EO-1 and EO-3 functioned properly though the EO-2 debris plunger had not seated. No debris was found on the runway beneath the ET/ORB umbilical cavities when the ET doors were opened, but a loose wave spring was found resting against a Hi-Lock fastener on the LH2 umbilical door. The wave spring is part of the pyro separation device. All of the umbilical separation ordnance retention shutters were closed properly.

The EO-2 plunger was not seated. No flight hardware was found on the runway below the umbilical when the ET door was opened, but a loose wave spring from the pyro separation device was found resting against a fastener on the ET door
